This document addresses transceiver-related known errata for the Stratix<sup>®</sup> GX FPGA family production devices.

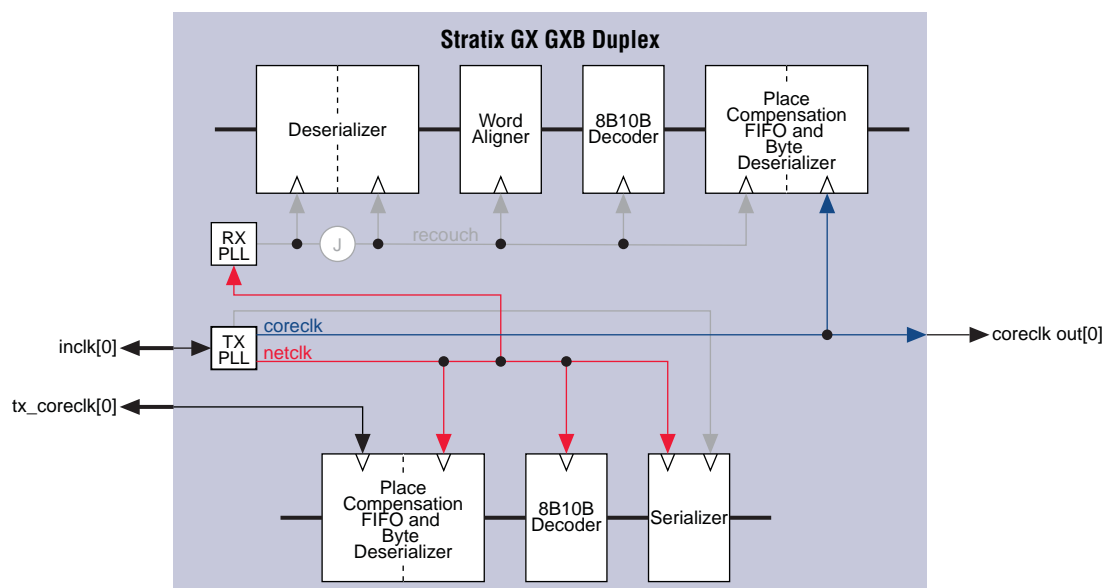
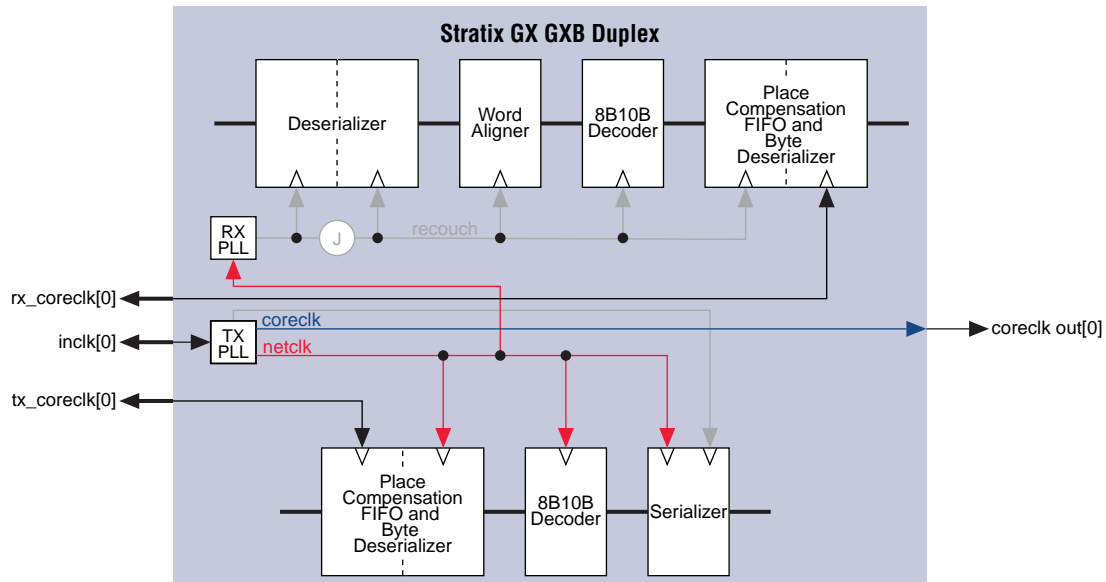
[Figure 2](#) and [Figure 3](#) show clocking schemes with potential byte misalignment problems.

**Figure 2. Gigabit Transceiver Block Clock Configuration that can Potentially Cause Byte Misalignment Problem, Example 1**

**Figure 3. Gigabit Transceiver Block Clock Configuration that can Potentially Cause Byte Misalignment Problem, Example 2**

The clocking configurations in Figure 2 and Figure 3 can only work if both the read and write clocks to the phase compensation FIFOs are of the same frequency. Take proper precautions to ensure that there is no frequency variation anytime after the link has been initialized. This means that you must perform a receiver digital reset via the `rxdigitalreset` signal to ensure that the pointers within the receiver phase compensation FIFO are properly spaced.

If you are using these clocking configurations, you must be aware that, in these configurations, the output byte alignment can potentially vary between six different permutations. That is, after the de-assertion of the `rxdigitalreset` signal, the byte ordering can deviate from the previously explained two permutations.

The recommended workaround is to run the gigabit transceiver block in the default clocking scheme, as described above, and implement a phase compensation FIFO in the FPGA logic array. This configuration of the gigabit transceiver block will prevent byte misalignment. This would utilize additional resources and increase latency in the datapath. A phase compensation FIFO can be implemented in the FPGA logic array

using a Dual Port RAM, however you decide on the FIFO parameters to meet system specifications. Another thing to be aware of is the additional clock resources needed for this implementation. Each channel will require the use of a global, regional, or fast regional routing resource for the recovered clock (`rx_clkout`) to be routed out of the gigabit transceiver block. Figure 5 shows an example of this workaround.

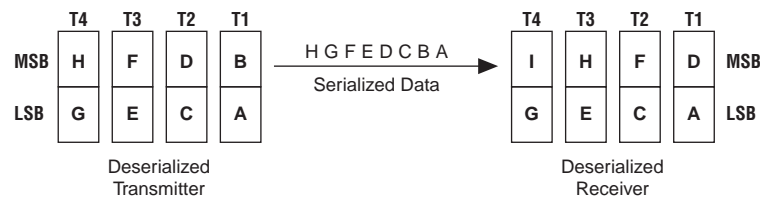
If the transceiver is clocked by any of the methods other than the default method described above, there is a possibility of byte misalignment. Figure 4 provides an example of byte misalignment.

**Figure 4. Byte Misalignment at the Receiver Interface**

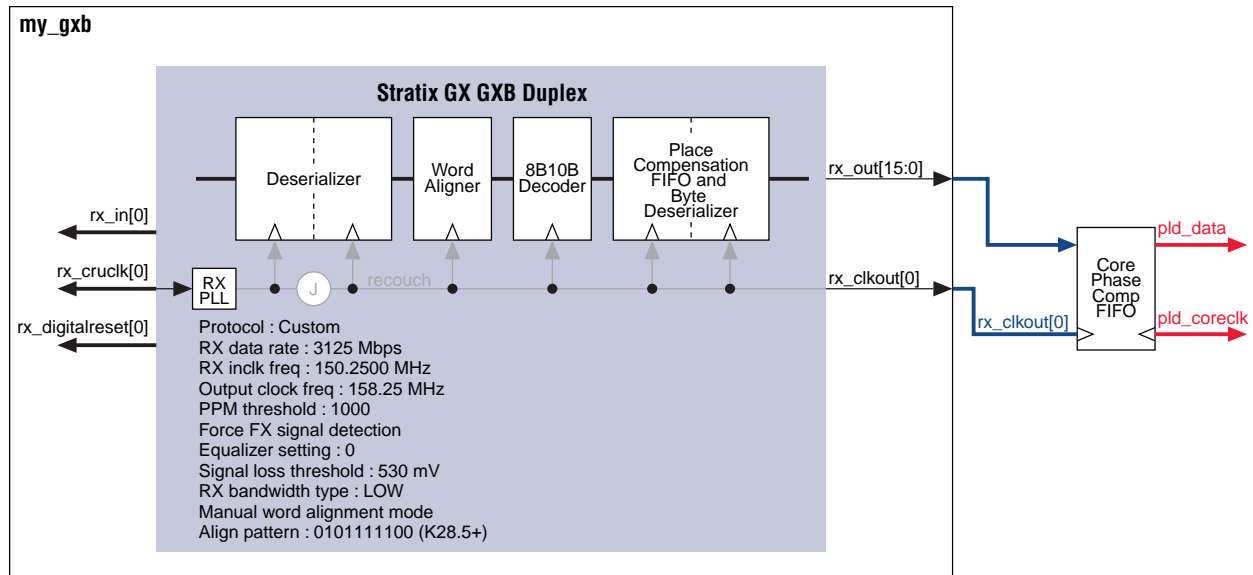
**Figure 5. Block Level Example of Byte Re-Alignment Logic**

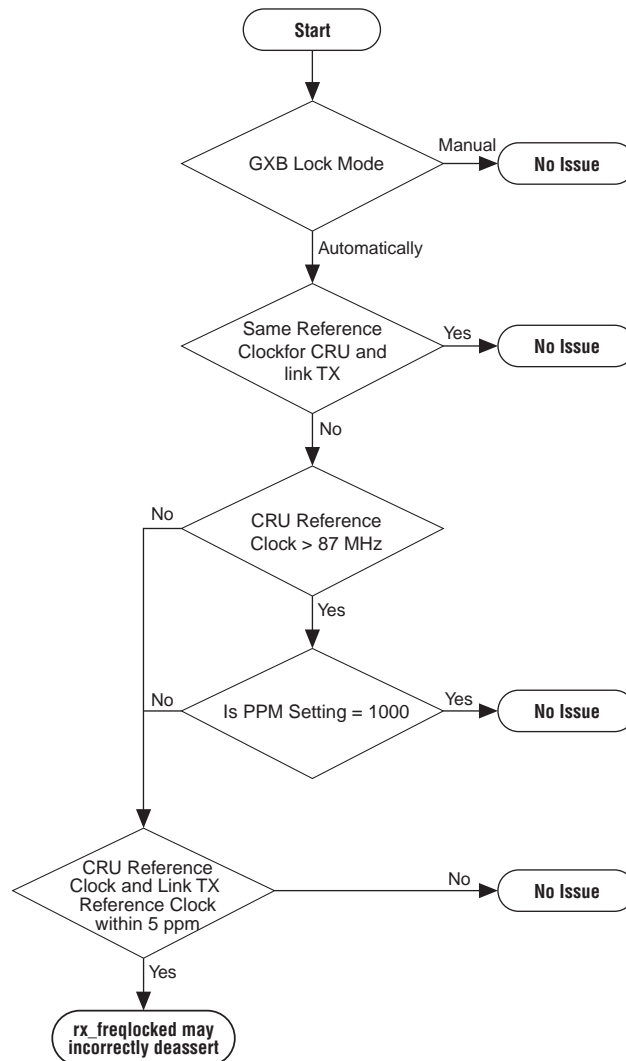
Under certain conditions, the rx\_freqlocked signal has an issue in the automatic lock mode. The rx\_freqlocked signal might incorrectly deassert even if the CRU PLL and the CRU reference clock are within the selected PPM frequency threshold detector setting.

The rx\_freqlocked signal can demonstrate incorrect behavior if:

- The CRU reference clock and the link TX clock are not from the same source AND
- The PPM difference between the CRU reference clock and the recovered clock is less than 5 PPM AND
- Input reference clock is between 25 MHz and 87 MHz

**Figure 8. Determine if the Stratix GX Design is Affected**

Altera recommends using the manual lock mode for the transceivers. Design the PPM frequency threshold detector in the PLD fabric. A design example for implementing the PPM frequency threshold detector can be found at:
