SerialLite II MegaCore Function v7.0 Issues

The Generation Fails or a Corrupted Variation Is Generated When the Asymmetric Broadcast Mode Is Used

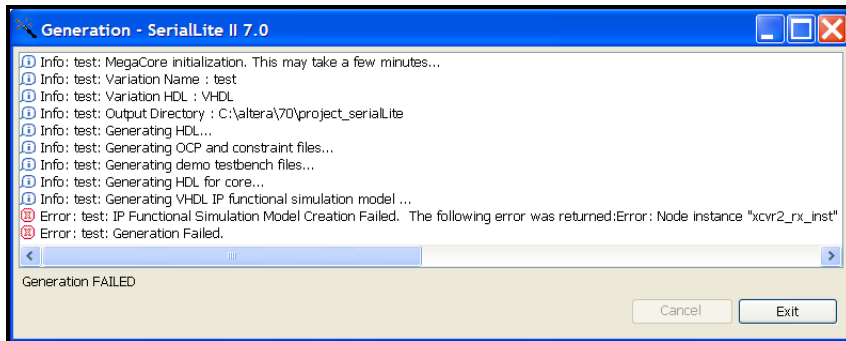
Figure 1. Syntax Error Message

If the state machine is not self-synchronized, the syntax error shown in [Figure 1](#) appears and the generation fails. If the state machine is self-synchronized, an invalid configuration is generated, data is corrupted, and the testbench fails.

This issue affects configurations that use the broadcast mode and for which the transmitter number of lanes does not equal the receiver number of lanes (asymmetric).

If the self-synchronized state machine is required, use the MegaWizard interface to generate a transmitter-only broadcast variation. Use the MegaWizard interface again to generate a single lane receiver-only self-synchronized variation. Then instantiate as many of these receiver variations as required to match the number of lanes needed.

You cannot select options such as retry-on-error and flow control for your workaround variation.

If self-synchronized state machine is not required, there is no workaround other than to use a self-synchronized state machine and configure the system as previously described.
