This errata sheet provides updated information about known device issues affecting Arria® II GX devices.

Introduction

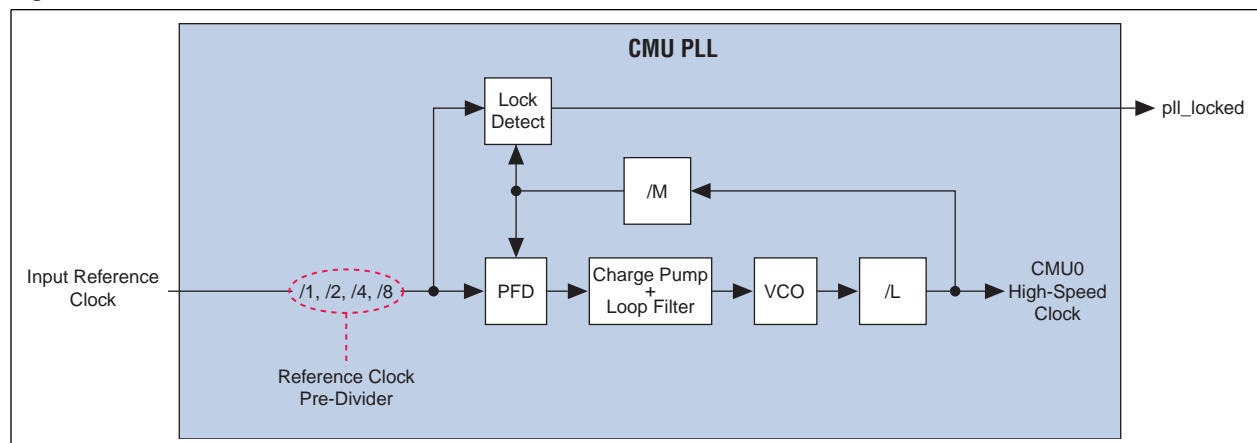
Figure 1. Reference Clock Pre-Dividers in Transmitter PLLs

The transmitter phase-locked loop (PLL) lock status signal (pll_locked) does not de-assert when the pll_powerdown signal is asserted in configurations that use the reference clock pre-divider of 2, 4, or 8. Figure 1 shows the reference clock pre-divider inside transmitter PLLs. This issue impacts the pll_locked status signal in the clock multiplier unit (CMU) PLL.

- Designs that implement the recommended transceiver reset sequence described in the *Reset Control and Power Down in Arria II Devices* chapter in volume 2 of the *Arria II Device Handbook* could potentially see a link failure after coming out of reset.

If the pll_locked issue impacts your design, instantiate and connect the pll_locked_soft_logic module, as shown in **Figure 3**. You must use the pll_locked_to_corelogic output from this module in the transceiver reset logic and any user logic that relies on the transmitter PLL lock status signal.

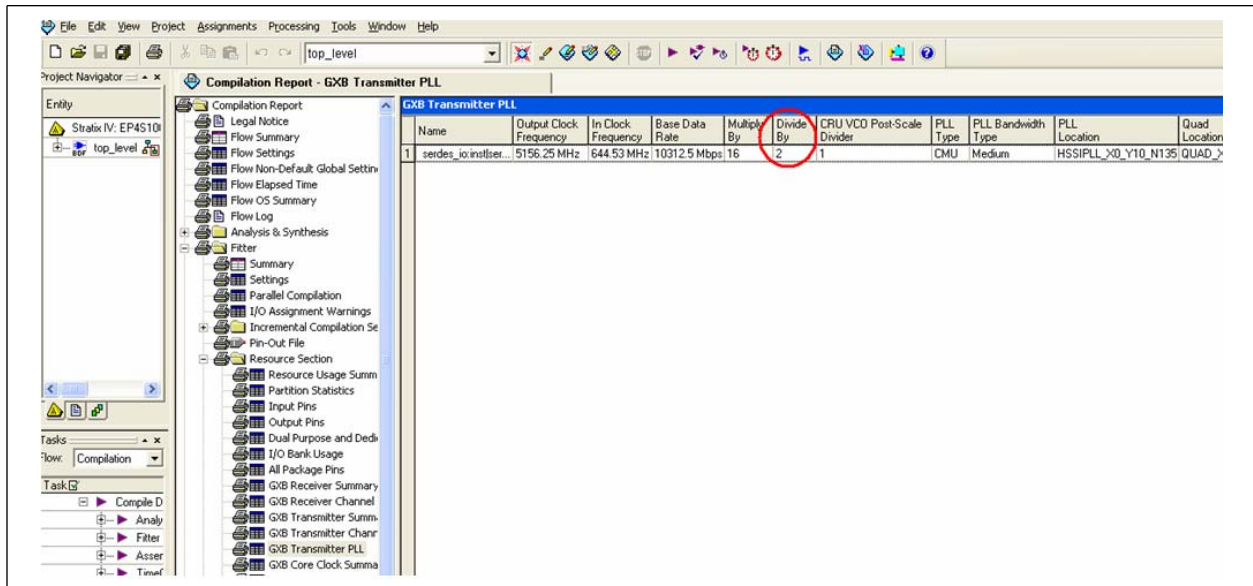
Figure 2. Determining Reference Clock Pre-Divider Value in the Compilation Report

You can determine if the Transmitter PLL in your design uses a reference clock pre-divider of 2, 4, or 8 by referring to the Quartus II software Compilation Report. **Figure 2** shows an example of the “GX B Transmitter PLL” report, which you find in the “Resources Section” under “Fitter” in the Compilation Report. If the value in the “Divide By” column reads 2, 4, or 8, your design is impacted by the pll_locked status signal issue.

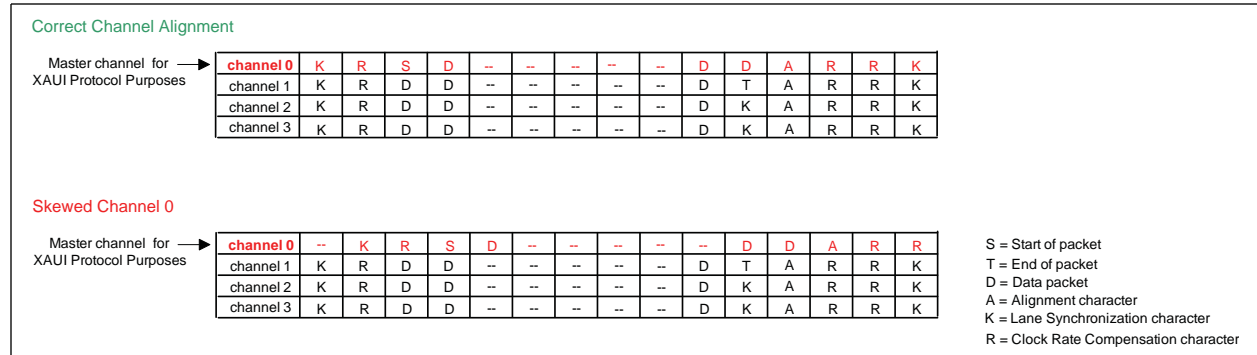
Figure 4. Rate Matcher FIFO Skew

In XAU functional mode, the data out of the channel 0 Rate Match FIFO may be shifted by one byte with respect to the data of the other three channels. This causes incorrect idle ordered set conversion, resulting in incorrect received parallel data. This issue happens only during initialization or receiver channel reset (assertion of `rx_analogreset` or `rx_digitalreset`).

Figure 4 shows the channel skew.

A soft IP solution for this issue is available by contacting Altera.
