This errata sheet provides updated information on known device issues affecting Cyclone® IV devices.

Table 1 lists specific Cyclone IV issues and which Cyclone IV devices are affected by each issue.

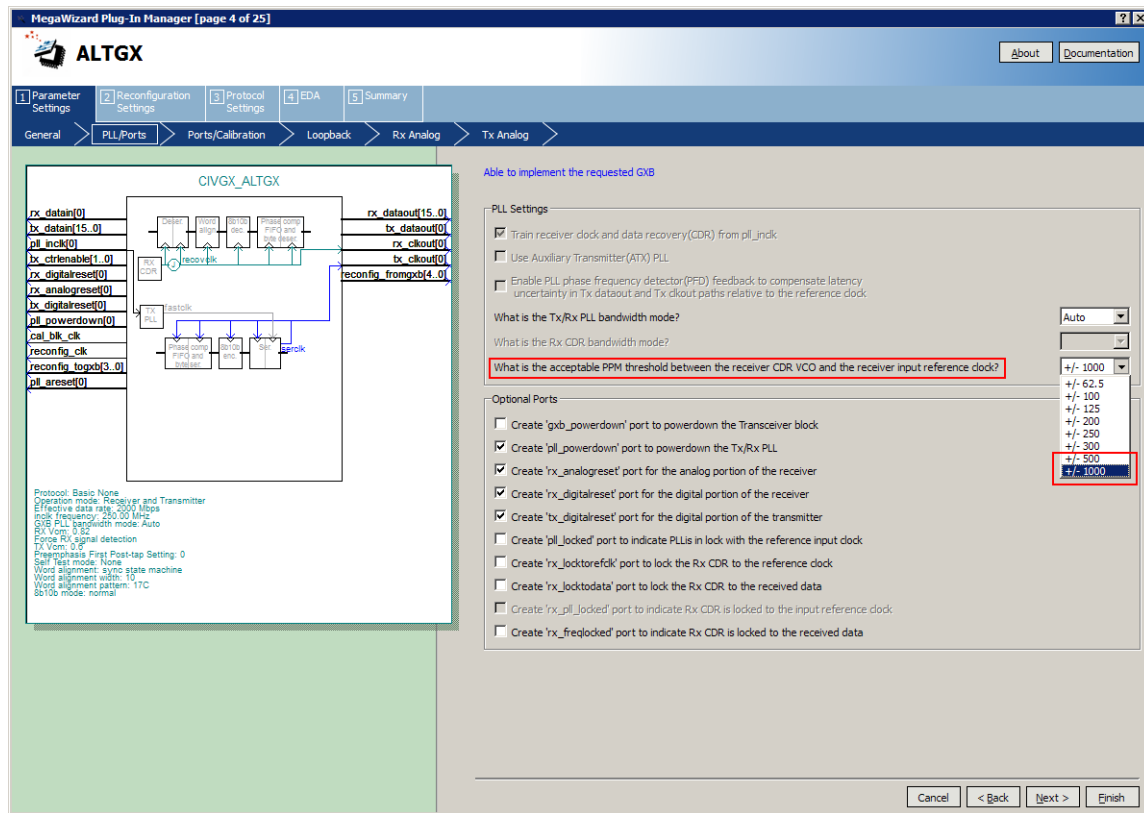
Figure 1. Programmable PPM Detector Options in the ALTGX MegaWizard Plug-In Manager

The ± 500 PPM and ± 1000 PPM options for the Programmable PPM Detector feature in the ALTGX MegaWizard™ Plug-In Manager, as shown in [Figure 1](#), are no longer supported in the Quartus II software version 10.0 SP1 and later. These options are removed because the programmed PPM threshold values exceed the receiver CDR PPM tolerance between the upstream transmitter reference clock and the local receiver reference clock.

Designs compiled with the Quartus II software version 10.0 and earlier may have a link failure risk when the receiver is operating in a system that has ± 500 PPM or ± 1000 PPM differences for the reference clock frequencies between the upstream transmitter and the local receiver. Using CDR Manual Lock mode does not overcome the link failure risk.

For a receiver design that has the ± 500 PPM or ± 1000 PPM options selected in the Programmable PPM Detector feature, Altera recommends evaluating the system operation with different options, ranging between ± 62.5 PPM and ± 300 PPM. To change the **Programmable PPM Detector** option, regenerate and recompile the ALTGX MegaWizard Plug-In Manager design file with the supported options.
