## Introduction

This errata sheet provides updated information on Cyclone™ II devices. This document addresses known device issues and includes methods to work around the issues.

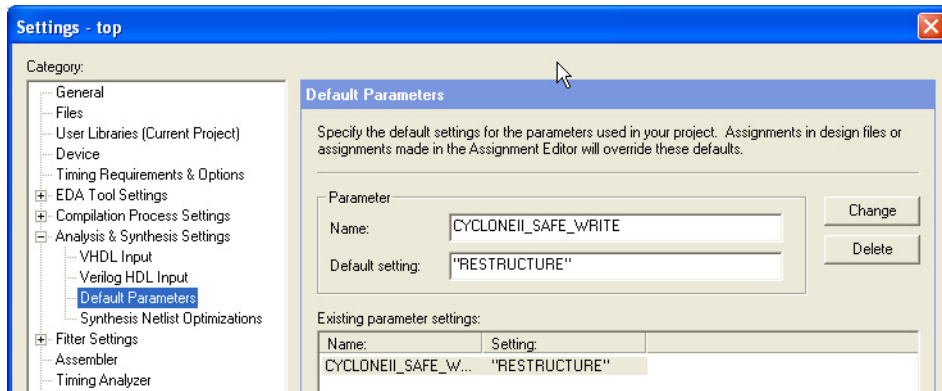
**Figure 2. Setting CYCLONEII\_SAFE\_WRITE Parameter Globally**

Designers must set the CYCLONEII\_SAFE\_WRITE parameter for memory configurations that require the Quartus II software to remap the design. If the parameter is not set correctly, the compilation will result in an error.

Use the following steps to set the CYCLONEII\_SAFE\_WRITE parameter globally:

1. From the Assignments menu, click **Settings**.

2. Under Analysis & Synthesis, select **Default Parameters**.
3. Enter the desired parameters.

Designers can make an assignment to a specific entity in the Assignment Editor to affect only that entity. **Figures 2** and **3** show where to make the parameter assignment in the Quartus II software.
