This document addresses transceiver-related known errata for the Stratix<sup>®</sup> GX FPGA family production devices.

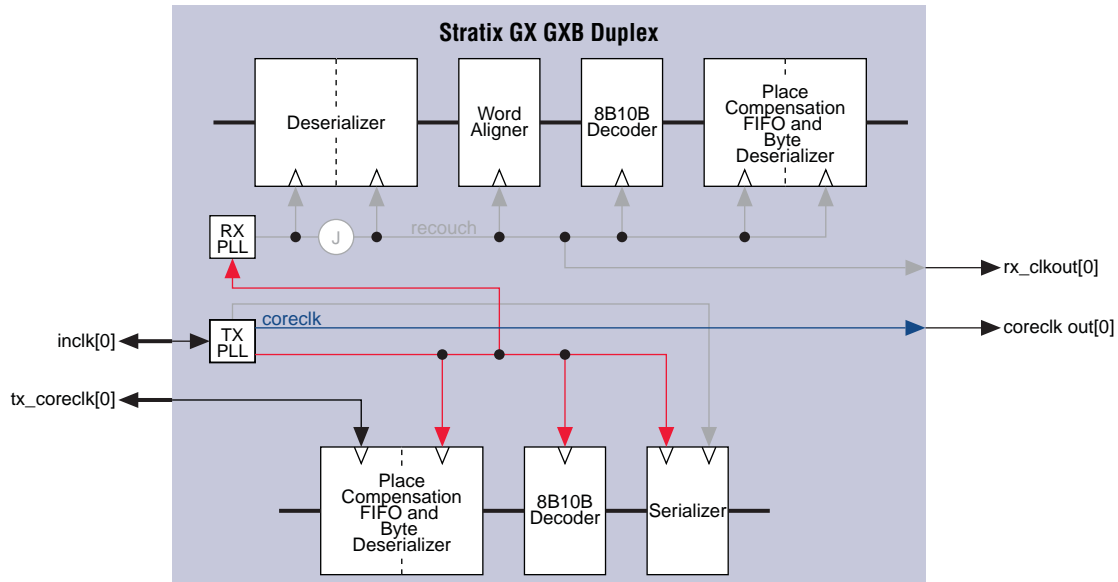
**Figure 1. Gigabit Transceiver Block Clock Configuration that Does Not Cause Byte Misalignment Problem**

This problem only occurs if the read clock of the phase compensation FIFO of a channel is fed from a clock source other than its own recovered clock. For example, [Figure 1](#) shows a clock configuration that avoids this problem.

From [Figure 1](#), the recovered clock (`rx_clkout[0]`) is fed to both the read and write clocks of the phase compensation FIFO. This is the default configuration of ALTGX megafunction. The Quartus<sup>®</sup> II software automatically routes the clocks into both sides of the FIFO to ensure that proper timing is met.

The recommended workaround is to run the gigabit transceiver block in the default clocking scheme, as described above, and implement a phase compensation FIFO in the FPGA logic array. This configuration of the gigabit transceiver block will prevent byte misalignment. This would utilize additional resources and increase latency in the datapath. A phase compensation FIFO can be implemented in the FPGA logic array

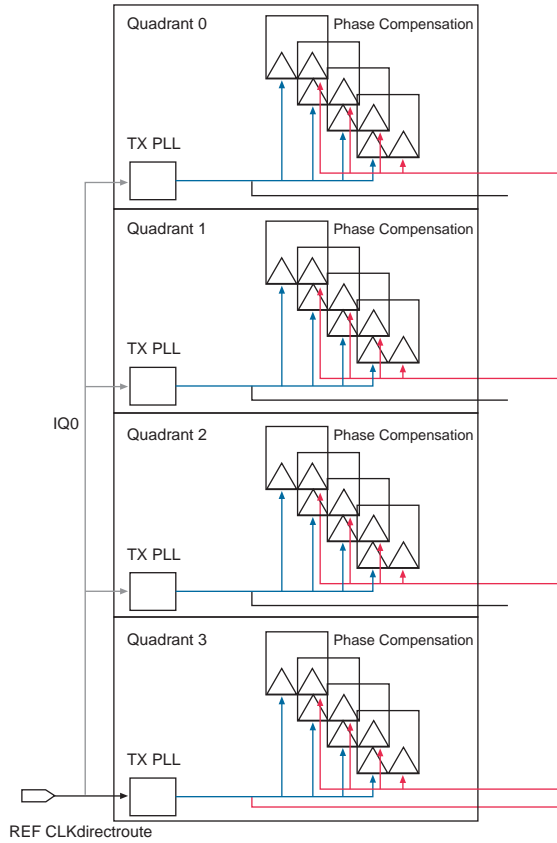
**Figure 6. Transmit Phase Compensation FIFO Clocking Across Quadrants over IQ Lines**

Figure 6 and Figure 7 show the clocking schemes allowed for transmit phase compensation.

FIFOs that share a transmitter PLL `refclk` output from one transceiver block across transceiver blocks. [Figure 6](#) shows IQ routing used for the `refclk` output across quads. [Figure 7](#) shows global clock routing being utilized.
