Introduction

The Stratix® GX device does not have delay information for the following paths:

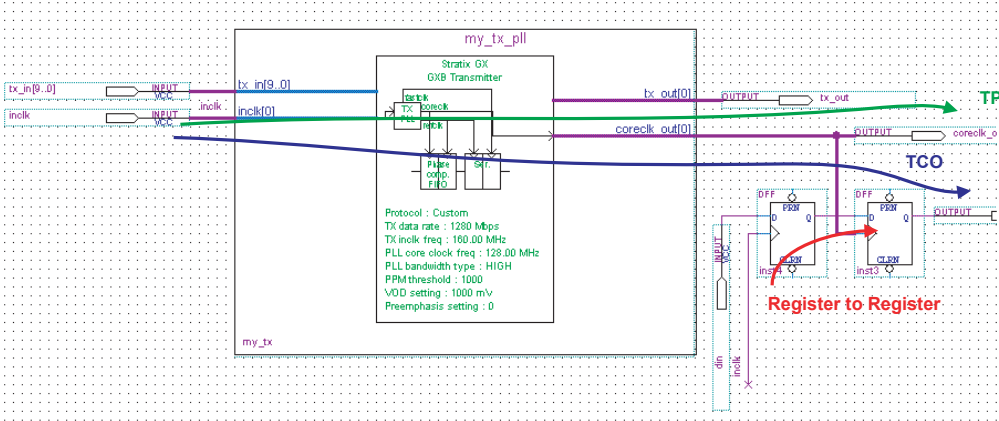
Figure 5-1 highlights the paths that trigger warning messages from the Fitter. The Fitter reports an incorrect path delay for these paths.

Figure 5-1. Transmit PLL `coreclk_out` Showing t_{PD} & t_{CO} Registers

- t_{PD} warning messages
The starting point (GXB Transmitter PLL `coreclk`) feeds an I/O pin directly. This configuration causes the Fitter to incorrectly report t_{PD} . [Figure 5-1](#) shows the t_{PD} (propagation delay) from `inclk` to the transmitter PLL through `coreclk_out` to the IO pin. Some example warnings are provided below.

- t_{CO} warning messages
The starting point feeds an I/O register directly. This configuration causes the Fitter to incorrectly report t_{CO} . Clock connectivity to I/O pins through registers originating from a GXB transmitter PLL `coreclk` is not recommended (see [Figure 5-1](#)). In this case, `coreclk_out` from the transmitter PLL clocks a register (`inst3`) and the output of that register is connected directly to an output pin. Because `coreclk_out` is related to `inclk` and there is no delay information from `inclk` through the transmitter PLL to `coreclk_out`, the Fitter reports incorrect t_{CO} .

The Fitter generates register-to-register warning messages because of the clock domain crossing from `inclk` (input clock to the transmitter PLL) to `coreclk_out` (output of the transmitter PLL).

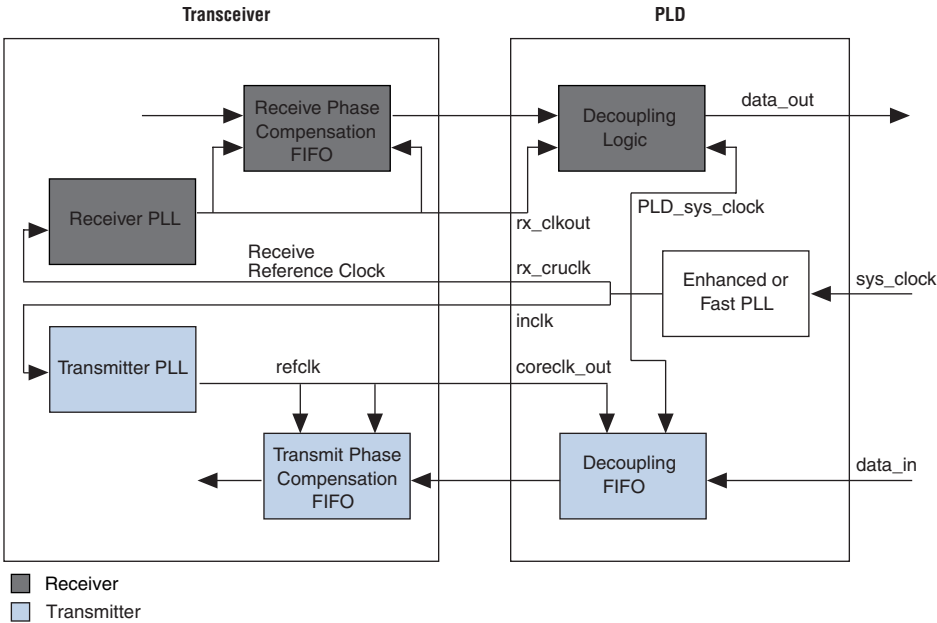
Figure 5-4 shows a system-level clocking scheme you can use to work around the issues described in this chapter. This clocking scheme may not be the most optimal for designs that have tight jitter requirements because of cascading PLLs.

Figure 5-4. PLD & Transceiver Clocking Scheme
